DEPARTMENT OF TRANSPORTATION**DIVISION OF ENGINEERING SERVICES**

Contract #: 04-0120F4Cty: SF/ALA Rte: 80 PM: 13.2/13.9File #: 1.28**WELDING INSPECTION REPORT****Resident Engineer:** Casey, William**Address:** 333 Burma Road**City:** Oakland, CA 94607**Report No:** WIR-027423**Date Inspected:** 10-Apr-2012**Project Name:** SAS Superstructure**OSM Arrival Time:** 700**Prime Contractor:** American Bridge/Fluor Enterprises, a JV**OSM Departure Time:** 1300**Contractor:** American Bridge/Fluor Enterprises, a JV**Location:** Job Site**CWI Name:** As noted below**CWI Present:** Yes No**Inspected CWI report:** Yes No N/A**Rod Oven in Use:** Yes No N/A**Electrode to specification:** Yes No N/A**Weld Procedures Followed:** Yes No N/A**Qualified Welders:** Yes No N/A**Verified Joint Fit-up:** Yes No N/A**Approved Drawings:** Yes No N/A**Approved WPS:** Yes No N/A**Delayed / Cancelled:** Yes No N/A**Bridge No:** 34-0006**Component:** SAS OBG**Summary of Items Observed:**

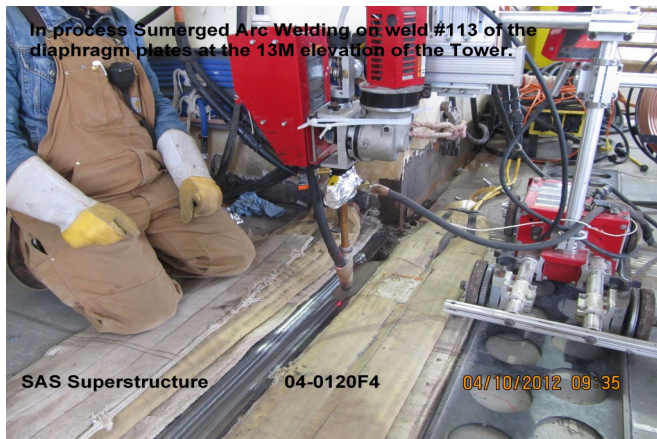
This QA Inspector randomly observed QC Inspector Fred Von Hoff perform a Magnetic Particle (MT) inspection of diaphragm weld #114 and 115 at the 13M elevation of the Tower. It was noted that Mr. Von Hoff found no rejectable indications. This QA Inspector performed an MT Inspection on the diaphragm welds at the same location. This QA Inspector performed the yoke method in conformance with ASTM E 709 and the standard of acceptance with D1.5 section 6.26. This QA Inspector noted that no rejectable indications were found at the time of testing. This QA Inspector generated a TL-6028 MT report on this date. The completed work at this location appeared to be in general conformance with the contract specifications.
